Guidance, Navigation & Control (GN&C)

Best Practices for Human-Rated Spacecraft Systems

Program Management Challenge 2008

26-27 February 2008

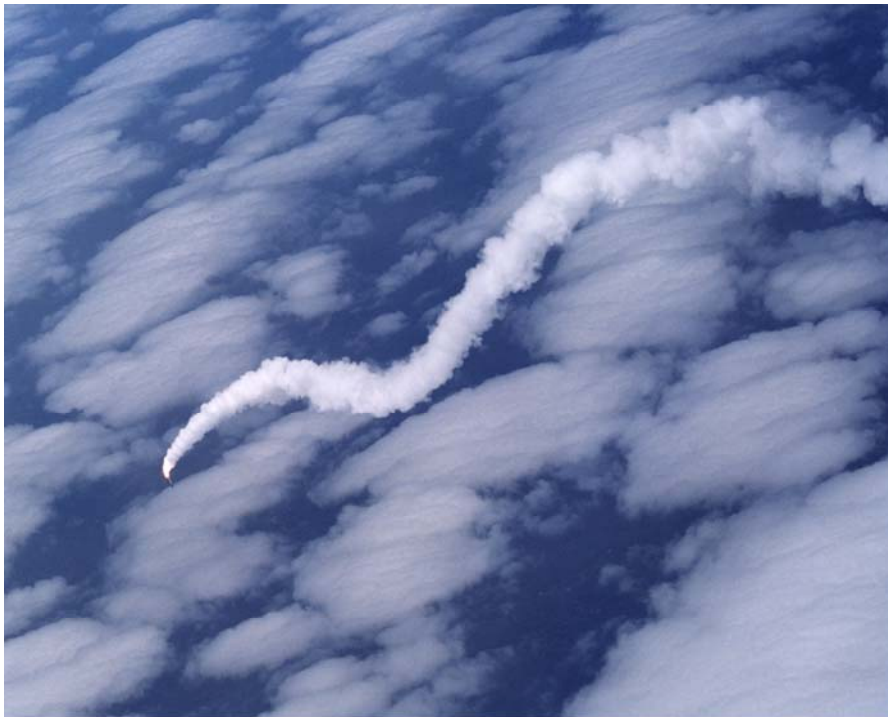
X-43A / Pegasus Launch June 2, 2001

NASA Dryden Flight Research Center Photo Collection
<http://www.dfrc.nasa.gov/gallery/photo/index.html>
NASA Photo: EC01-0182-11 Date: June 2, 2001 Photo by: Jim Ross
The X-43A/Pegasus combination dropped into the Pacific Ocean after losing control early in the first free-flight attempt.

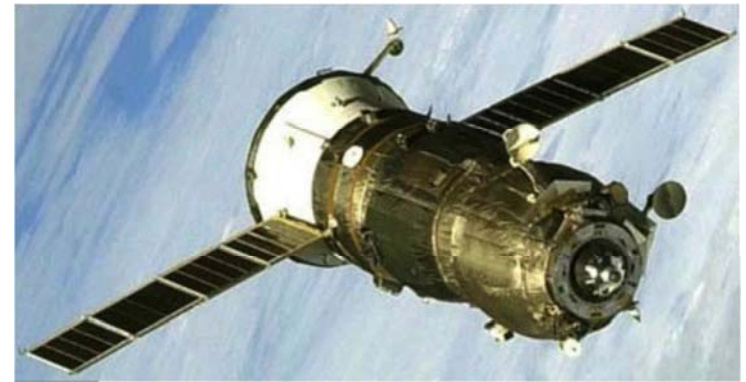
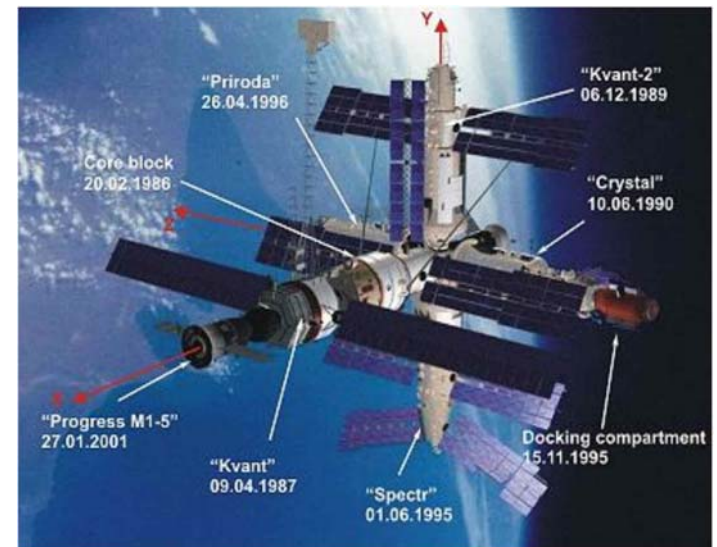
Top-Level Summary of the Progress M-34 Mishap

- Progress-M spacecraft are unmanned cargo and resupply vehicles used to send equipment to Mir.
- On 6/25/97 a 2nd test was performed of the manual Toru proximity docking system as a lower cost substitute for the autonomous Kurs rendezvous and docking system.
- Operator on Mir had difficulty determining range and range rate with the Kurs radar switched off.
- Progress M-34 went off course and collided with a solar array and radiator on the Spektr module and then the module itself.
- Spektr hull was breached causing significant air loss before Spektr module could be sealed off.
- Evacuation of the station was narrowly avoided.
- There were three immediate causes of the crash:
 - The higher than planned initial closing rate
 - Late realization that closing rate was too high
 - Incorrect final avoidance maneuvering

1. Range was to be determined by observing the size of a video image of Mir taken by a camera on Progress. The sole source of range rate information was the changing angular size and position of the image.
BP #9: The range rate measurement scheme was not qualified.
BP #5: No independent way was provided to determine a fault in the range rate measurement.

2. The operator continued to maneuver and aim for the docking port after noticing that the closing rate was higher than expected.
BP #14: Failure to explain test anomalies.

3. Post crash simulations show that the rendezvous trajectory was passively safe so that if the operator had stopped maneuvering in time the collision might have been avoided.
BP #6: Pre-test Systems Engineering did not flow down appropriate requirements to insure the safe interaction between the vehicles.
BP #3: Opportunity for passive abort option not taken advantage of.

4. The operator could not realistically train and rehearse the rendezvous in advance because there were no simulation training facilities onboard Mir.
BP #22: There was no provision to “Train as They Fly”.

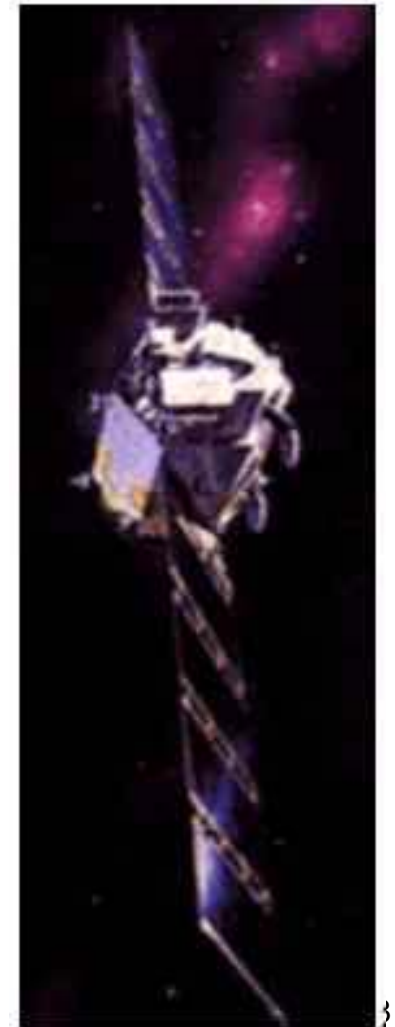
Top-Level Summary of the LEWIS Mishap

- 1. At launch, LEWIS was under control of the A-side processor. At first contact it had already switched to the B-side and was unable to playback SSR data.**
- 2. After 45 hours of nadir pointing on B-side, the Ground crew switched control back to the A-side. The attitude was uncontrolled so the A-side Sun pointing mode was entered.**
- 3. After verifying that the spacecraft had been stable in the Sun mode for four hours of operation, the Ground crew entered a nine-hour rest period and ceased operations for the day.**
- 4. During that unattended period, the spacecraft entered a flat spin that resulted in a loss of solar power and a fatal battery discharge. Contact with the spacecraft was lost on August 26.**
- 5. The spacecraft re-entered the atmosphere and was destroyed on September 28, 1997.**

1. Safe mode was adapted from the TOMS spacecraft which had its X-axis normal to the solar array. The X-axis was the major moment-of-inertia axis on the TOMS-EP spacecraft but it was the intermediate moment-of-inertia axis on Lewis.
BP #8: Over-reliance/Over-Confidence on TOMS heritage.
BP #1: GN&C Safe mode architectural was not iterated.

2. X-axis spin rate was not sensed and could not be controlled.
BP #3: Ensure implementation of comprehensive Abort/Safe Haven strategies/functions.
3. The Ground crew failed to adequately monitor spacecraft health and safety during the critical initial mission phase.
BP #21: Ensure sufficiency of GN&C engineering telemetry data.

4. X-axis rate produced disturbance torques in other axes resulting in excessive thruster firings which led to autonomous shutdown of thrusters.
BP #13: Understand & completely analyze the dynamics in ALL flight phases.

5. In the absence of control, the spacecraft dynamics transferred spin from the X to the Z axis with the solar array edge on to the Sun.
BP #15: Independent Truth Model should have identified un-modeled effects.

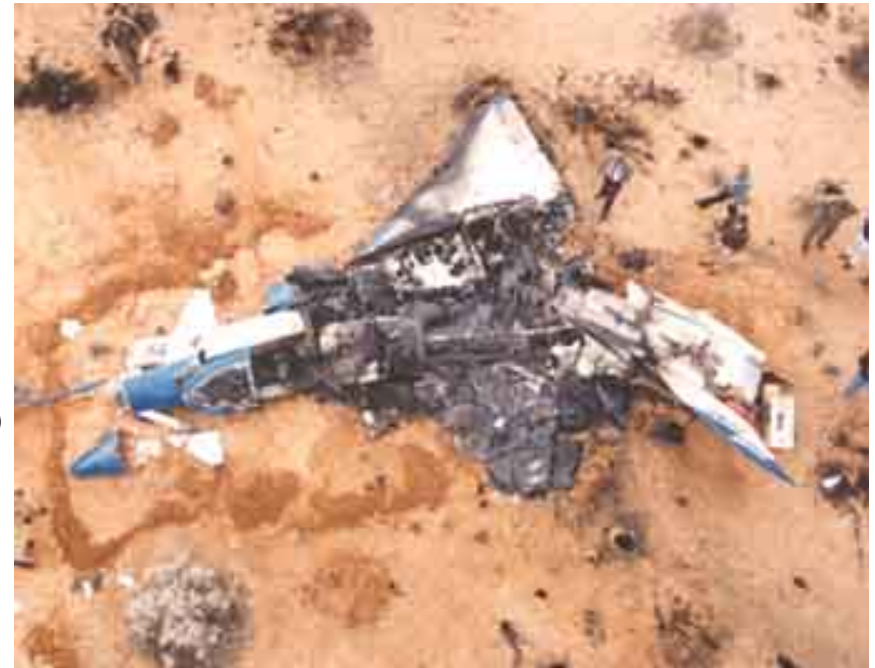
Top-Level Summary of the X-31A Mishap

- The final flight of the X-31A was through atmospheric conditions conducive to icing.
- The flight went as planned until an ice buildup blocked the pitot tube.
- The Flight Computer used invalid air speed data to generate attitude control commands.
- Inappropriate commands resulted in uncontrollable/divergent pitch oscillations.
- The pilot ejected at 18,000 ft. and parachuted to the ground.
- A NASA mishap-investigation board concluded that an accumulation of ice in or on the unheated pitot-static system was the proximate cause of the crash.
- Underlying Issues included:
 - Incomplete/improper interpretation of hazards analysis
 - Breakdown in configuration management and change documentation
 - Failure to impose proper ops controls and take preventative action

1. The decision to install a new airspeed probe without a heater assumed that no flights would be made through conditions conducive to icing. The test pilot was unaware that the pitot heater switch was not working.
BP #10: Failure to design for test.
BP #20: Failure to coordinate information on potential hazard due to change in configuration.

2. Spurious air speed readings were noticed as ice built up and pilot switched ON the inoperative heater. Control room debated and finally replied that heater "...may not be hooked up" 9 seconds before warning tone and master caution light came on.
BP #14: Failure to explain test anomalies.

3. When the Flight control computers received erroneous airspeed inputs, flight control gains changed so drastically that the pilot could not maintain control.
BP #12: Insufficient control system stability margins.
BP #13: Lack of parametric uncertainty analysis for control system.

4. 'Fall-back' fixed gain reversion modes were available for such situations, but had not been practiced and the pilot had not been briefed on their potential use in the event of unreliable airspeed data.
BP #3: Abort/Safe Haven strategy (Reversion Mode) was not utilized.

5. Data from alternate air speed indicator that used a different pitot tube was ignored.
BP #7: Independent air speed sensor data was available but not utilized.

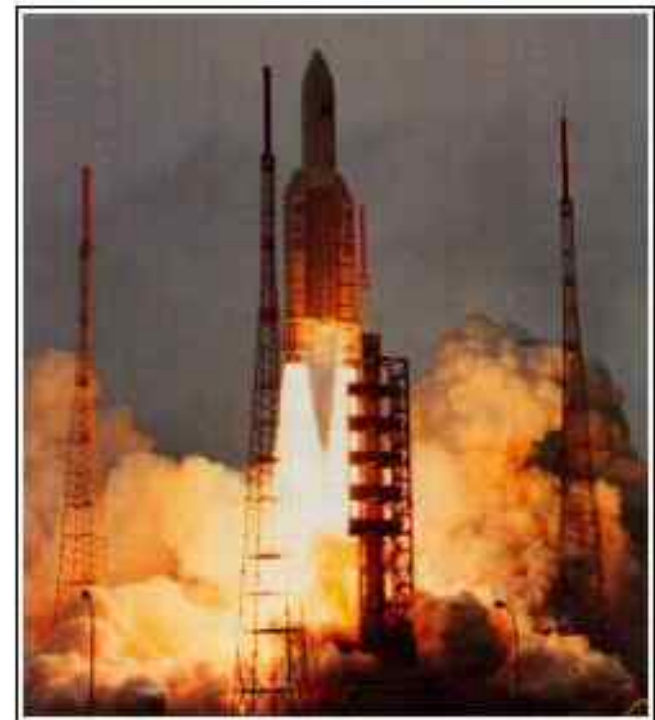
Top-Level Summary of the ARIANE-5 Flight 501 Mishap

- 39 seconds into the flight the primary Inertial Reference Unit (SRI-1) stopped sending correct attitude data due to a software exception.
- The On-Board Computer (OBC) switched to the backup inertial unit, but SRI-2 also failed due to its independently determined (and identical) software exception.
- The OBC could not switch back to SRI-1 so it took data that was actually part of a diagnostic message written to the bus by SRI-2. This data was interpreted as flight data and used for Thrust Vector Control (TVC).
- The sudden swivelling of both solid booster nozzles up to the limit caused the launcher to tilt sharply giving rise to intense aerodynamic loads leading to destruction of the vehicle.

1. Primary Inertial Reference Unit, SRI-1, stopped sending correct attitude data due to a software exception.
 - BP #2: Interactions between S/W and GN&C were not defined with enough care.*
 - BP #8: Heritage software for Ariane-4 was inappropriate for Ariane-5.*
 - BP #20: Database confusion over reference trajectories.*
 - BP #17: Failure to adhere to “Test as You Fly” approach.*
2. Switchover to the backup unit was accomplished, but SRI-2 immediately failed in the same way as SRI-1.
 - BP # 7: Evaluate if redundancy using identical GN&C components increases or decreases reliability.*
3. The OBC could not switch back to SRI-1 so it accepted SRI-2 diagnostic data as attitude data and generated improper TVC commands.
 - BP #3: Ensure that Abort/Safe Haven strategies/functions are properly implemented. Ariane-5 was lacking a simple and reliable “Never Give Up” flight control capability.*

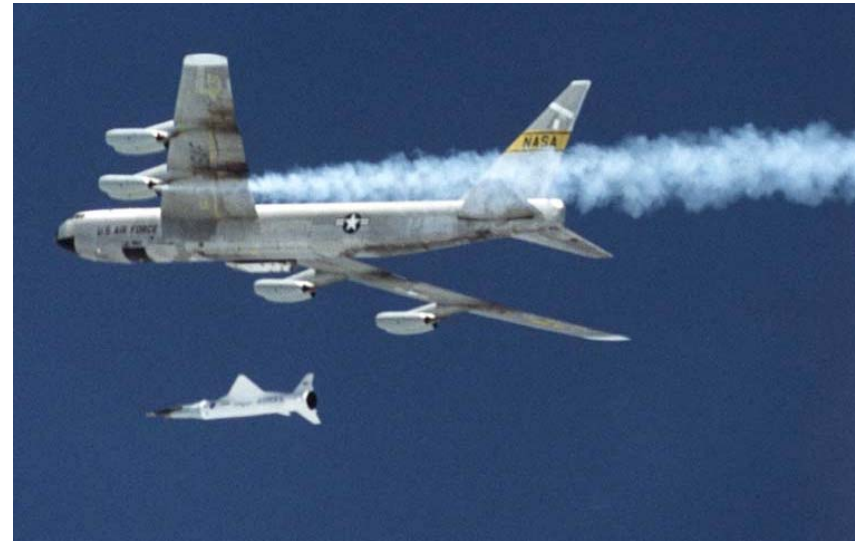
Top-Level Summary of the X-43A Mishap

- The trajectory that was selected to achieve the mission was at a lower altitude (i.e. a higher dynamic pressure) than a typical Pegasus trajectory.
- Flight went as planned after B-52 drop until pitch-up maneuver.
- Diverging roll oscillation at 2.5-Hz frequency occurred during pitch-up.
- Roll oscillation continued to diverge until about 13 seconds into flight.
- Rudder electro-mechanical actuator stalled & ceased to respond to autopilot at that point causing loss of yaw control.
- Loss of yaw control caused X-43A stack sideslip to diverge rapidly to over 8°.
- Structural overload of starboard elevon occurred at 13.5 seconds
- Loss of control caused X-43A stack to deviate significantly from planned trajectory.
- Vehicle terminated by range control about 49 seconds after release.

1. The vehicle control system design was deficient for the trajectory flown due to inaccurate analytical models which overestimated design margins.
BP #8: Over-reliance/Over-Confidence on Pegasus heritage.
BP #17: Failure to adhere to “Test as You Fly” approach.

2. Failure triggered by divergent roll oscillatory motion at 2.5 Hz, caused by excessive control system gain.
BP #12: Insufficient control system stability margins.

3. Modeling inaccuracies in fin actuation system & aerodynamics. Insufficient variations of modeling parameters.
BP #13: Lacking parametric uncertainty analysis for control system.

4. Rudder actuator stall occurred as consequence of divergent roll which accelerated loss of control.
BP #14: Inadequate dynamic modeling.
5. Flight failure was only reproduced when all modeling inaccuracies with uncertainty variations were incorporated in system-level linear analysis model & nonlinear simulation model.
BP #15: Independent Truth Model should have identified un-modeled effects.

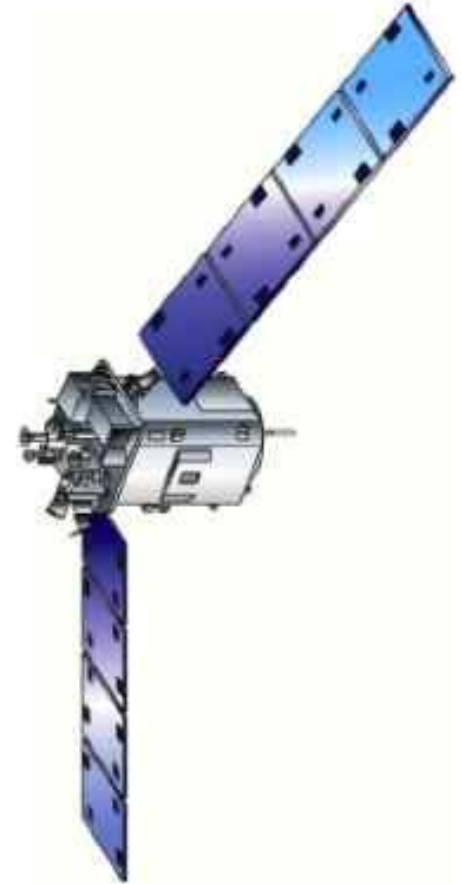
Top-Level Summary of the TIMED Mishap

1. Shortly after separation there was a steady increase in spacecraft system momentum.
2. Coming out of eclipse and seeing the Sun for the first time in Sun Pointing Mode, the spacecraft pointed an incorrect axis toward the Sun.
3. The Nadir Pointing Mode, which is used for Science observations, had an unanticipated 2.1 Hz oscillation.
4. Momentum dumping occurred 10 times/day rather than the expected once/day.

1. There was a Sign Error in the Momentum Unloading Control Logic.
BP #18: *True end-to-end sensors-to-actuators polarity tests not conducted.*
2. Two of the Sun Sensors were not in the flight configuration during ACS polarity test.
BP #17: *“Test As You Fly” philosophy was not enforced.*
3. There was a Controls-Structures Interaction (CSI) with the Solar Array Flex Mode which varied from 2.0-2.6 Hz depending on array orientation.
BP #2: *Interactions between GN&C, Power, and Structures were not well defined.*
BP #12: *Stability margins were not robust to parameter variations.*
4. The Spacecraft had a 10 A-m² Residual Magnetic Dipole.
BP #2: *Residual dipole requirement was not specified.*
BP #17: *Residual dipole was not measured in ground test.*
